The reasons for architectural monuments destruction and methods of capacity reinforce for bases and fundaments

Mykola Orlenko

Ukrainian special scientific-restoration project-build-production corporation "Ukrrestavratsiya" 6, Boryspilska str., Kyiv, Ukraine, 02099 <u>ukrrestavratsiya@ukr.net</u>, orcid.org/0000-0002-4154-2856

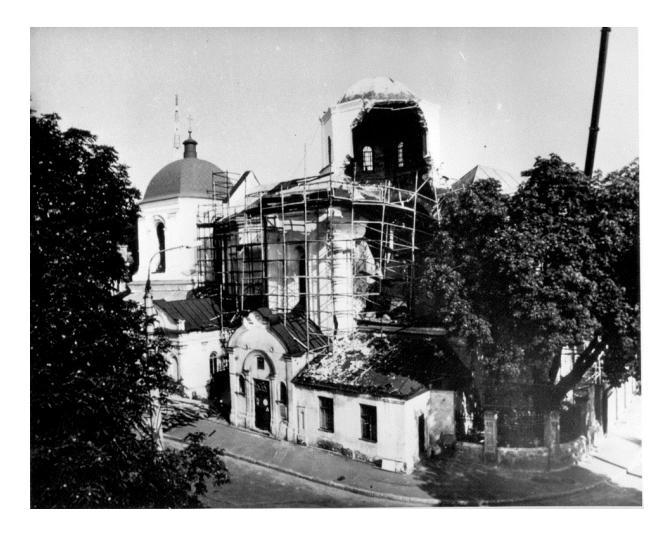
Fig.2. Alert condition of the Mykola Pritisk's church (Photo May 1983)

rier pylon and two reinforcing arches, which were based on it, cylindrical vaults and three sides of an octagonal drum were destroyed (Figs.2, 3).

The main reasons for the alert condition of the monument were raising the level of groundwater in recent years after the construction of the subway at Podil, which was like a dam and blocked the flow from Tarasivska and Zamkova mountains in the Dnieper, uneven subsidence of foundations that caused redistribution for efforts in carrying structures, which destroyed previously established balance in the base-foundation-building system.

Comparing the technical and economic parameters, as well as the considered options, the most rational was the use of root piles (Figs. 9 - 15).

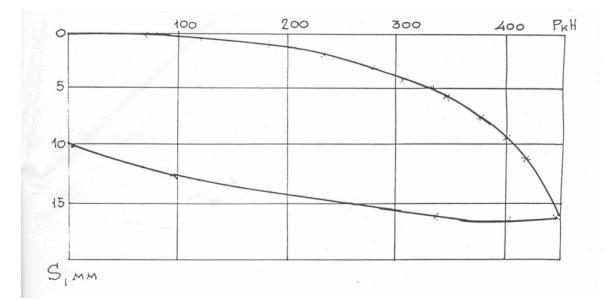
Fig.13. S = f(P) plot for the studied root pile DP-1 at strengthening the foundations of the Mykola Pritisk's church in Kyiv

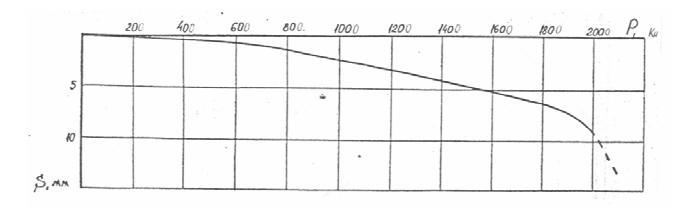
Fig.14. S = f(P) plot for the studied cluster of four root piles, connected with DR-1 rostverk at strengthening the foundations of the Mykola Pritisk's church in Kyiv

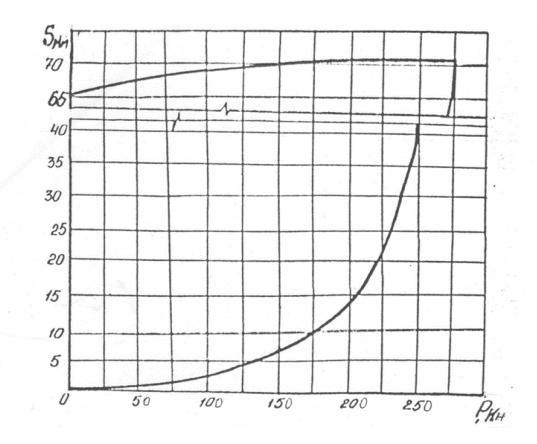
Fig.15. S = f(P) plot for the studied root pile DP-1 on the break at strengthening the foundations of the Mykola Pritisk's church in Kyiv

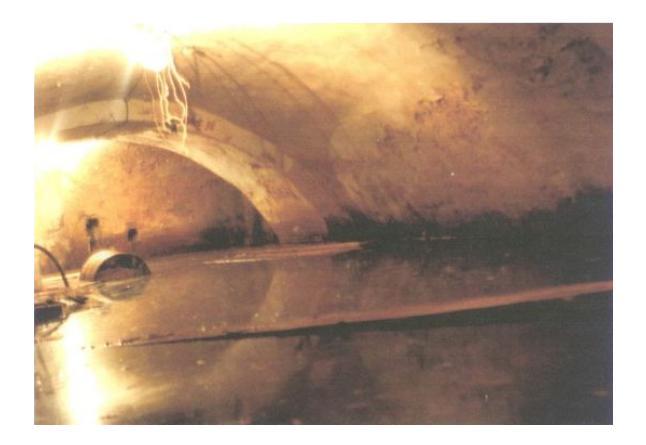
Fig. 16. Basement before the work

Basement moisture condition (Fig.16) was unsatisfactory, the basement was underflooded all the time and water was always there. The water level rose to a height of 40...50 cm from the floor and depended on changes in the level of groundwater. Moisture of the plaster exceed permissible limits, plaster was covered with efflorescence. In some places, there was peeling, breaking, and some heavy losses of laying bricks. In the north wall, bricks inrush amounted to 15 cm, cracks in walls and arches reached up to 30 mm.

1. The main reason for the church basement becoming soaked is the high level of groundwater.

2. At a height of 1,5 meters from the floor, high moisture of the church walls is caused by capillary suction of ground water.

3. To normalize moisture and the state of the walls, and to prevent the ingress of water into the basement, vertical and horizontal waterproofing must be performed.

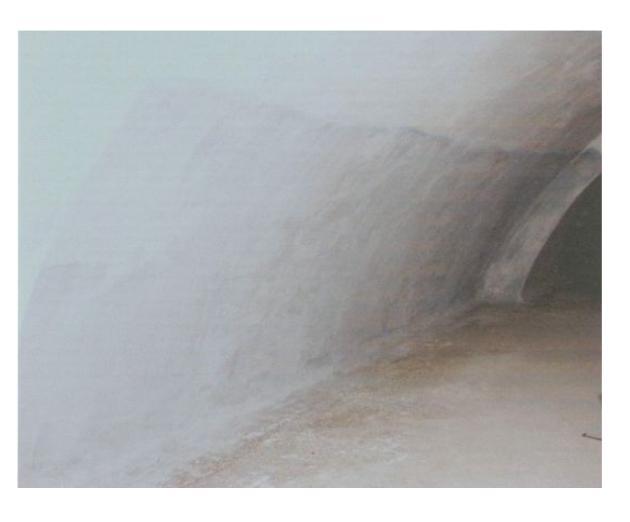
Fig.23. Basement after the work

After the full technological cycle of vertical and horizontal waterproofing arrangement, the moisture of the church walls, both outside and inside, become normal (Fig.23).
