Чисельне моделювання процесу руйнування залізобетонних балок монолітного огороження та його посилення вуглецевими матеріалами

Анотація. На стадії будівництва багатоповерхового будинку в м. Київ на залізобетонних балках монолітного огороження були виявлені тріщини. Причина їх виникнення не була з'ясована забудовником. Тому авторами були висунуті й зmodельовані в програмному комплексі “ЛИРА 2013” деякі припущення щодо їх появи.

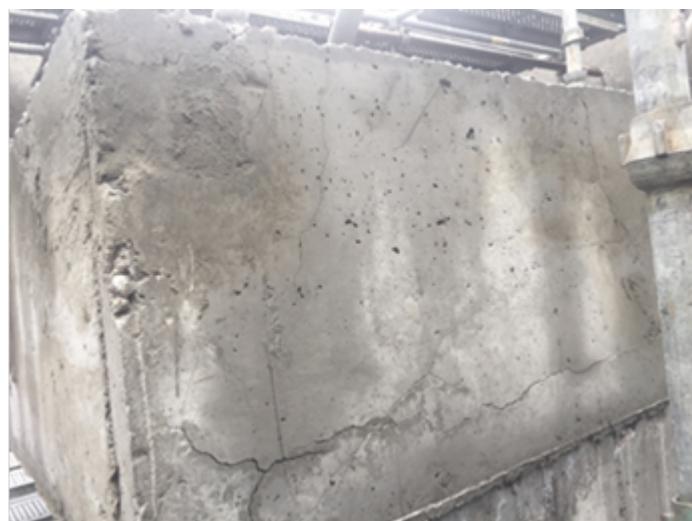
Рис. 2. Поверхневе розтріскування залізобетонної балки.

Fig. 2. Surface cracking of reinforced concrete beam.

Пошкодження представлені у вигляді нормальних і похилих тріщин локалізованих більшою мірою в розтягненій зоні конструкції (див. рис. 2-3), а також поврхневого розтріскування на конструкціях парапетів.

Виходячи із аналізу напруженодеформованого стану (ширини розкриття тріщин та прогинів конструкцій) рекомендується виконати посилення розтягнених зон балок, колони та парапетів на-

клєюванням вуглеplастикових ламелей із попереднім надійним закриттям тріщин методом ін'єктування тиксотропними епоксидними смолами.

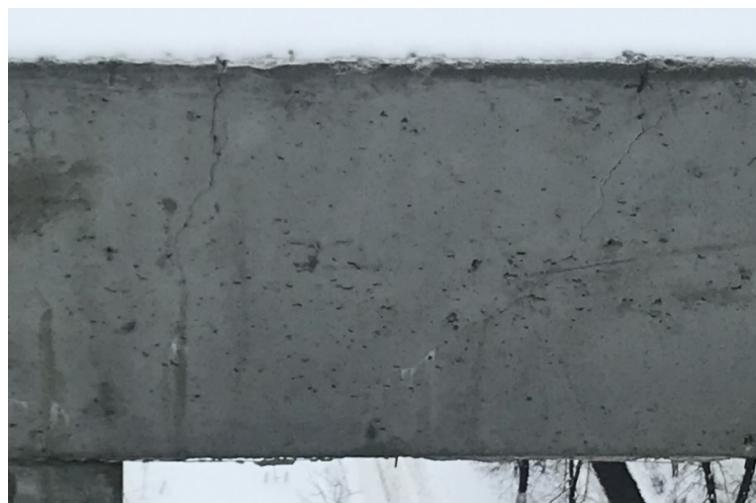
Рис. 3. Вертикальні та похилі тріщини в консольних балках.

Fig. 3. Vertical and inclined cracks in cantilever beams.

Аналізуючи можливі причини виникнення дефектів, дійсних прогинів балок зроблено припущення, що підпірні стойки опалубки ригелів були зняті до бетонування парапетів та набору міцності бетону, а проектну міцність бетон набрав після отримання прогинів та утворення тріщин. Швидкість набору міцності та швидкість росту модуля пружності бетону однакові, але на момент утворення тріщин та надлишкових прогинів міцність та, відповідно, значення модуля пружності невідоме. Для подальшого моделювання з метою визначення напружено-деформованого стану
