# Engineering and Geodetic Works during the Detailed Inspection of the Façade System of a Building Damaged as a Result of the Armed Aggression of the Russian Federation

Mykhailo Yakovenko, PhD Candidate<sup>1</sup>, Head of Laboratory, Geodetic Engineer<sup>2</sup> (ORCID: 0000-0001-7800-8166),

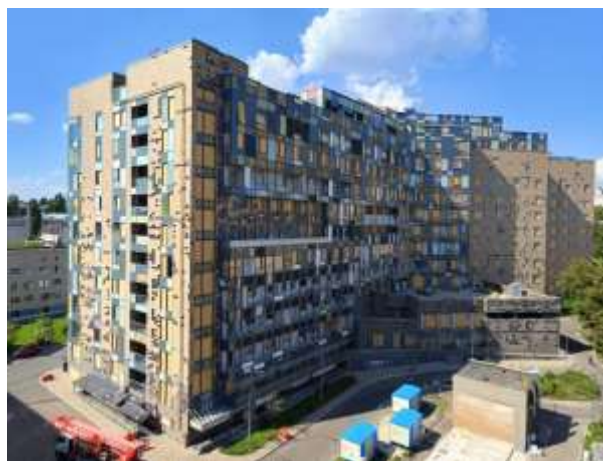
Figure 1. Exterior view of the inspected structure

As a result of the blast wave impact, the main task of the engineering and geodetic survey was to identify the areas of deformation and to detect hazardous sections of the façade system structures (Figure 1).

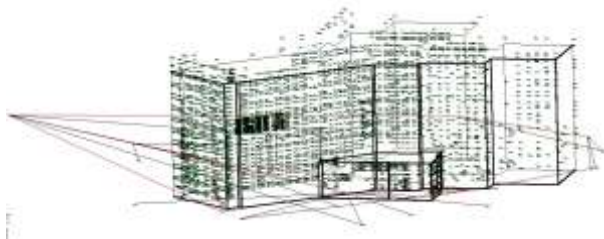
Figure 2. Three-dimensional point cloud

The survey of the spatial position of the structures was performed by coordinate measurement of the vertical posts of the façade system. The coordinates were obtained with an electronic total station operating in reflectorless mode. The point density during the façade system survey was selected to adequately represent the relief of the damage. The part of the façade damaged by the blast wave suffered the most severe destruction and geometric deformation; therefore, each vertical post and the vertical elements of the window frames were measured. The survey was carried out at each node of the façade system's fastening structures. The resulting spatial point cloud is shown in Figure 2.

To obtain the results of the spatial position of the façade structures, it was necessary to carry out office (post-processing) analysis of the geodetic measurements. The first stage was the adjustment of the closed traverse of the tacheometric survey. Next, the coordinates of the pickets (sighting points) were calculated in the required coordinate system. This produced a spatially adjusted (stitched) point cloud requiring further processing (Figure 2).
