The reasons for architectural monuments destruction and methods of capacity reinforce for bases and fundaments

Mykola Orlenko

Ukrainian special scientific-restoration project-build-production corporation "Ukrrestavratsiya" 6, Boryspilska str., Kyiv, Ukraine, 02099 <u>ukrrestavratsiya@ukr.net</u>, orcid.org/0000-0002-4154-2856

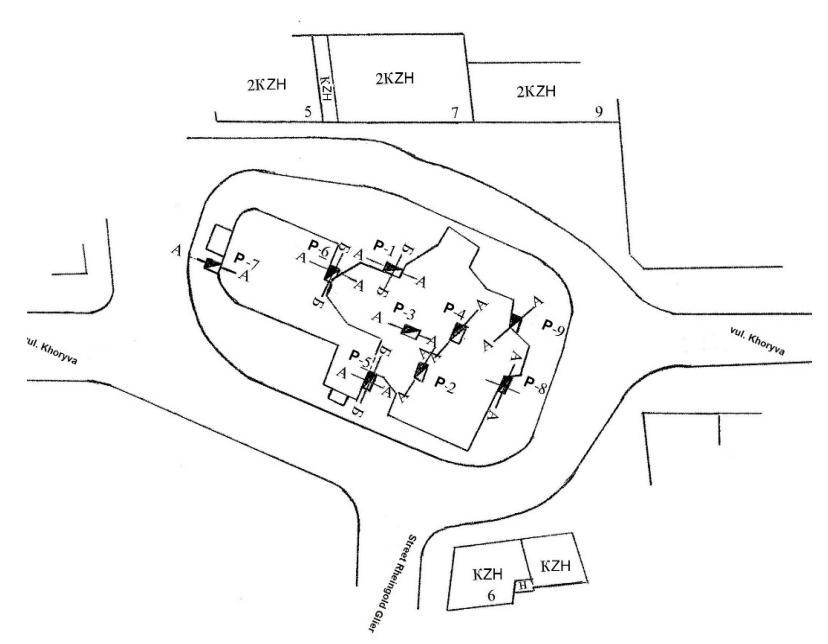
Fig.4. Layout for pits

To elucidate and clarify the reasons for the alert condition of the church, Ukrainian main state institute of engineering studies (UkrDI-INTD) performed a complex field, laboratory and cameral geological studies technical report in 1983 [11]. In 1984, 9 pits were made in addition to the previous studies to clarify the soil structure of the base and foundation material (Fig.4).

The foundation material, as it is seen from the pits, is uniform. In the pits number 1, 4 and 5, the foundation is made of bricks on limestone mortar. In the pits number 2, 3, 6 and 7, the foundation is made of rubble masonry (slab and granite boulders of 100 cm). The sole rubble foundations are located at a depth of 2,4 to 3,55 meters. After the rubble masonry, the brick masonry, which goes to the surface, is made. Sand and brickbat are used as a filler in the masonry. The masonry within the foundation in the pits 5, 8, and 9 has a vertical crack of 2 cm wide. Sections see Figs.5 – 8.
